Arrester Forensics

How to determine the cause of an arrester's last overload

9-13-23 R5
Jonathan Woodworth

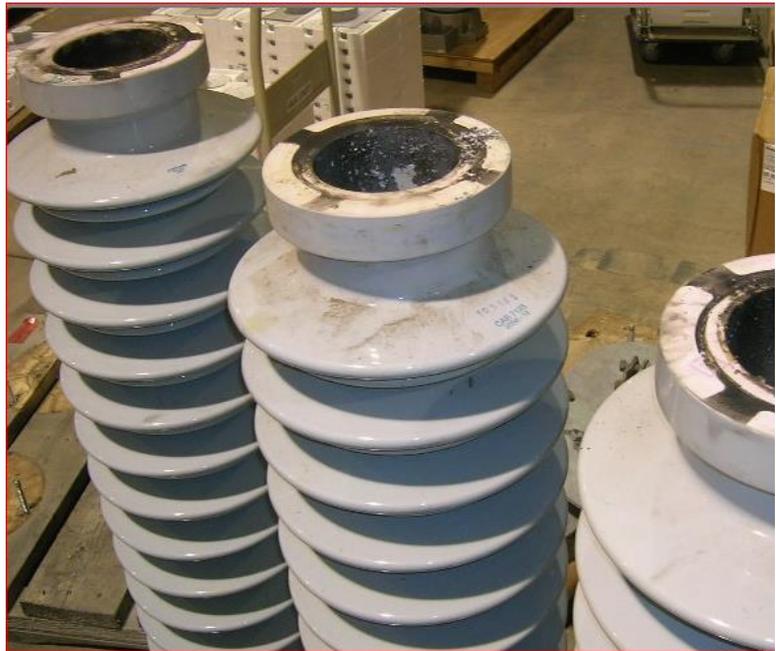
Figure 1 Porcelain Station Arresters with internal core that has experienced a fault current event

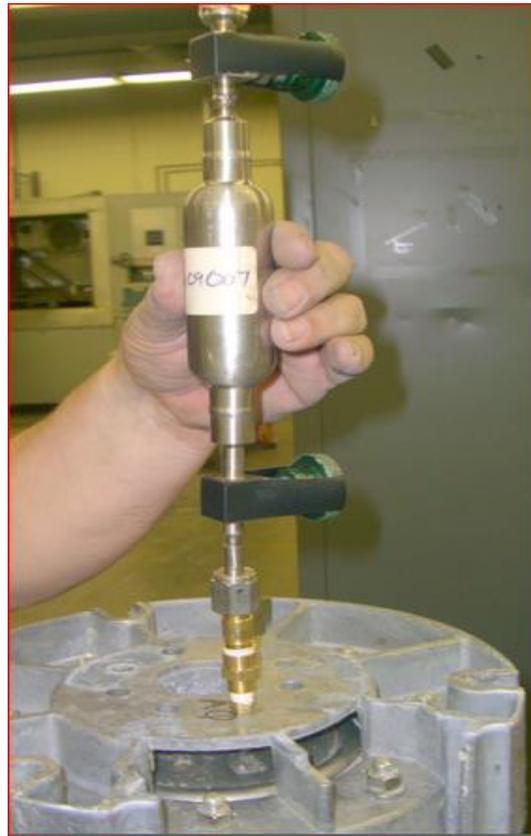
revealing. If this is desired, then before the arrester is disassembled, a gas sample should be drawn and analyzed. See Figure 2

Figure 2 Taking a gas sample of an unvented companion arrester can be very useful in the analysis

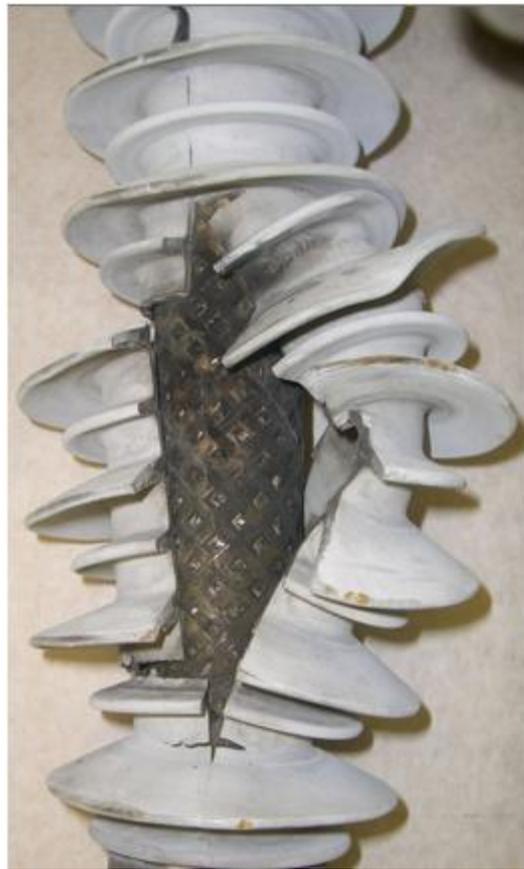
Figure 4 Example of Non-fragmenting nature of polymer housed arresters upon overload or failure

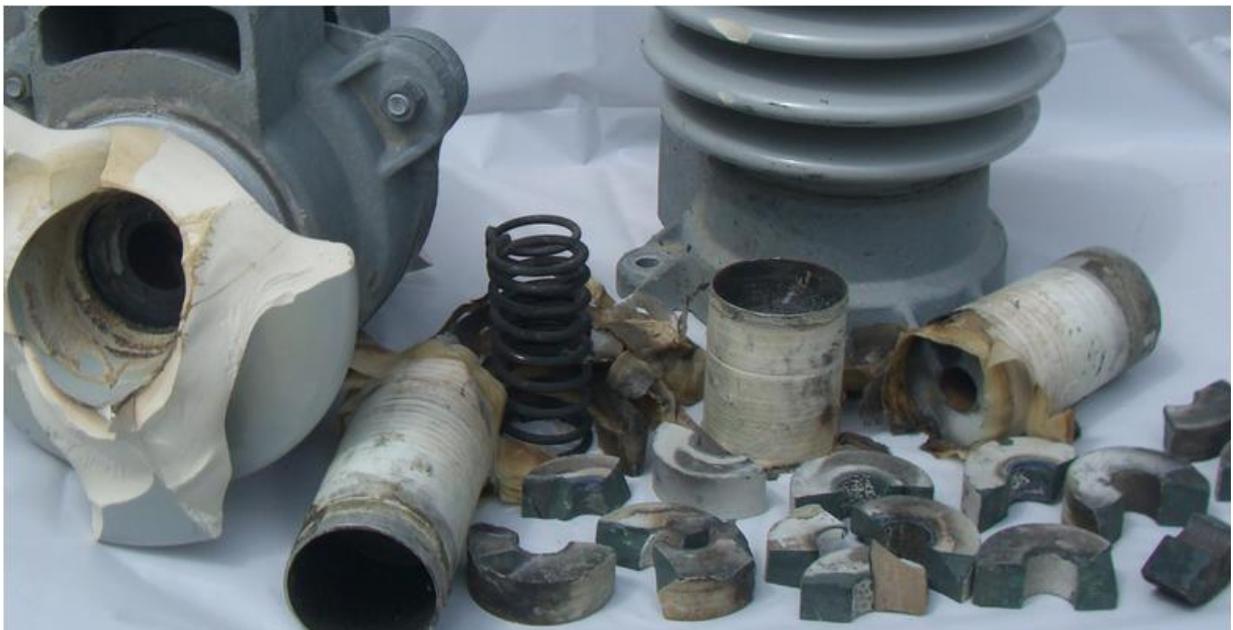
Figure 5 All too often Overload or Failure mode of Porcelain Station Arresters

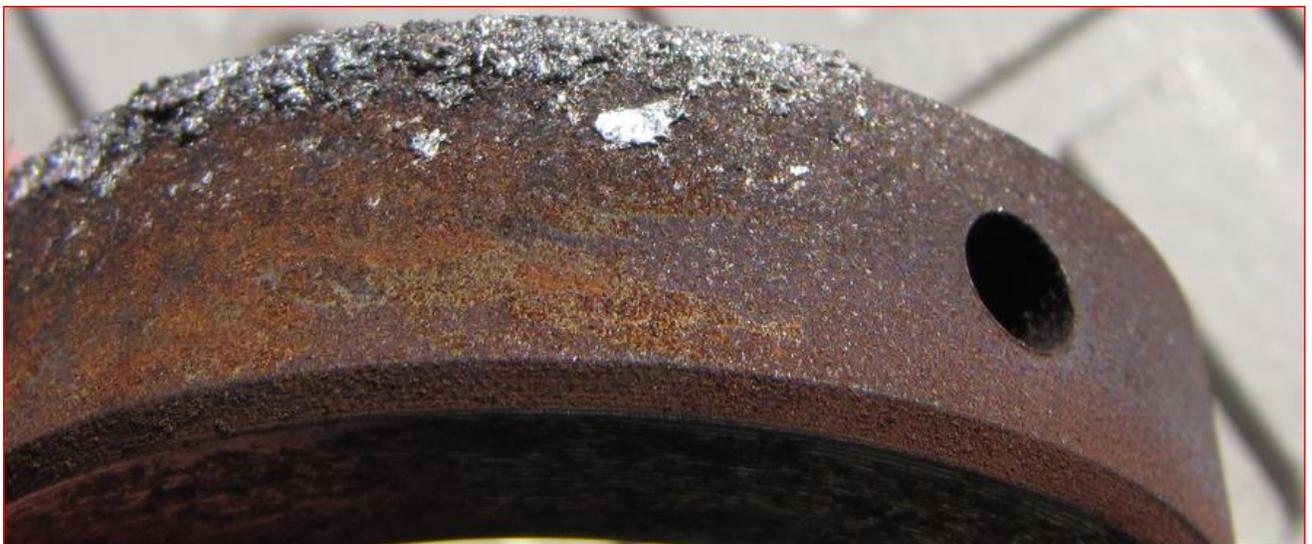
Figure 6 An internal steel component of a porcelain housed arrester that shows old and new rust along with molten metal over the old rust

Trick of the Trade: Old rust covered by carbon arc products indicate the rust was prior to the failure. See Figure 6

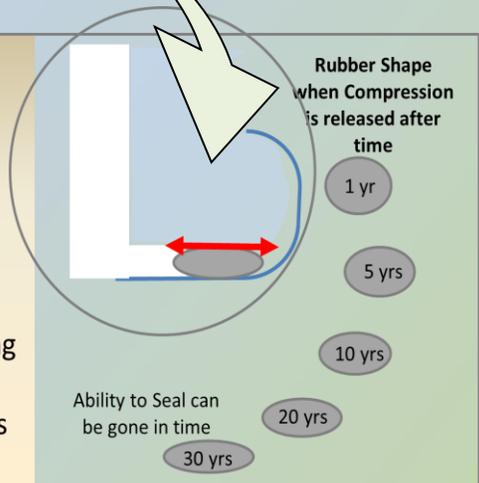
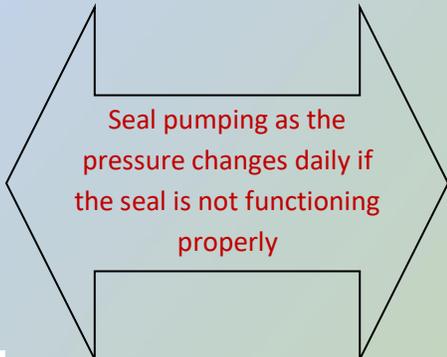
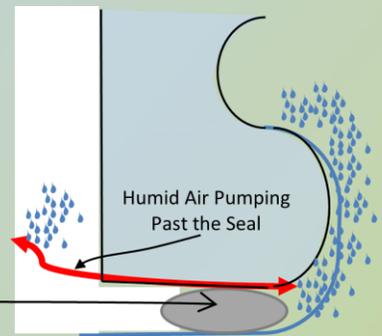
Figure 7 Seal Pumping - What is it?

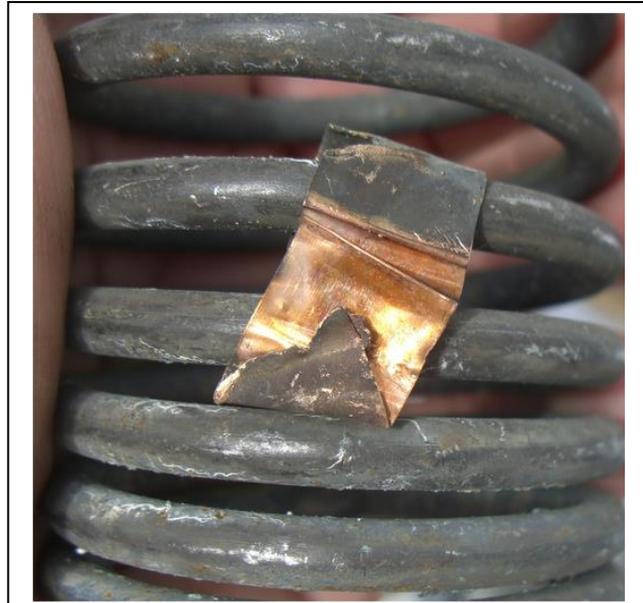
Figure 8 Shiny copper shunt implies no moisture ingress or excess partial discharge

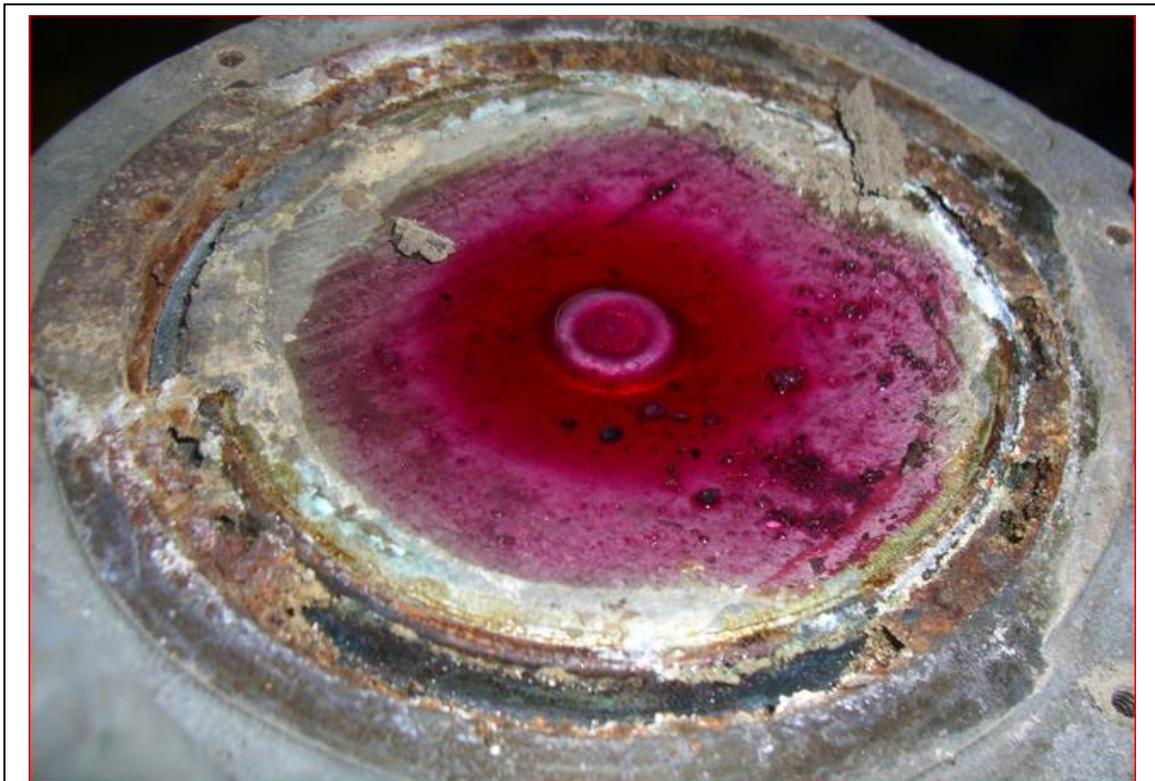
Figure 9 Red Die penetrating fluid can be very useful in locating cracks or pinholes in metal diaphragms

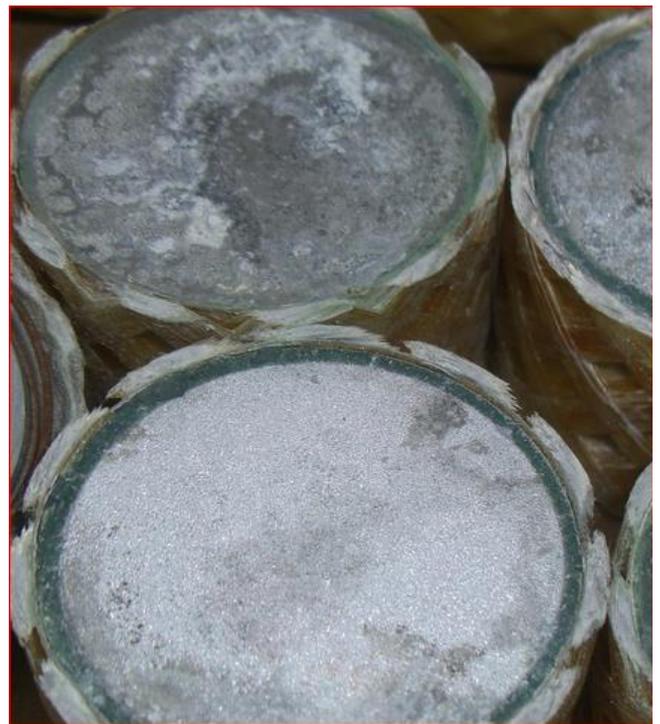
Figure 10 Evidence of Moisture in a solid core polymer housed arrester. Oxidized aluminum

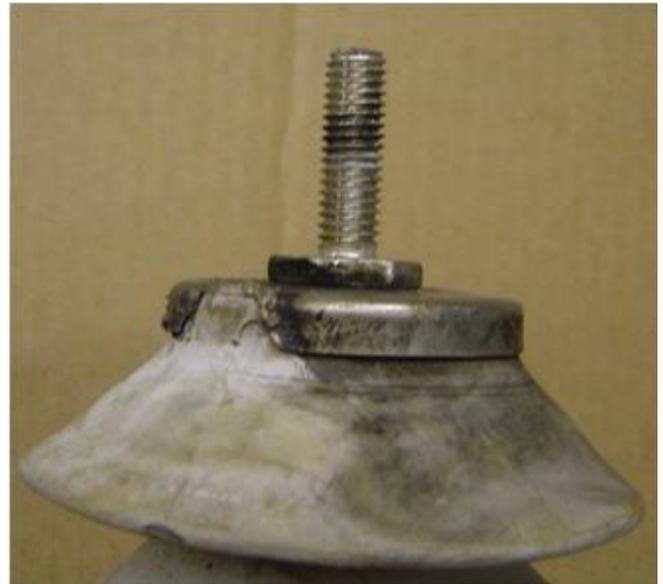
Figure 11 Arrester where external flashover did not fail the arrester, but damaged the seal

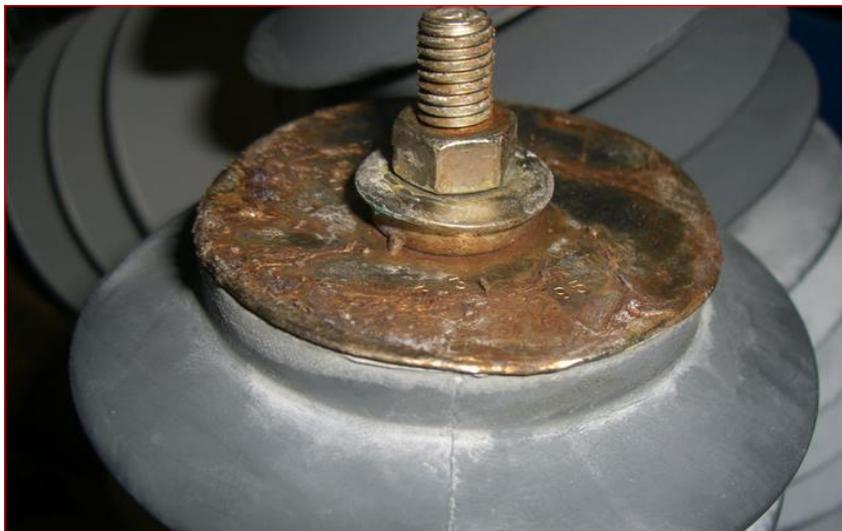
Figure 12 Top cap with clear arc marks from an external flashover. The seal may still be good in this arrester

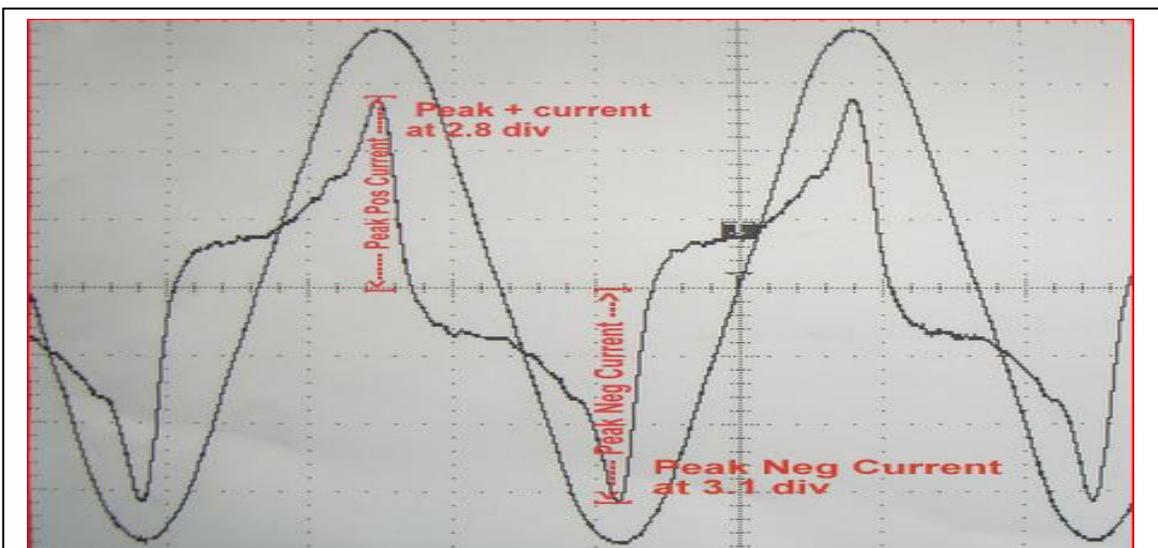
Figure 14 Example of Asymmetric Current through a surge degraded disk

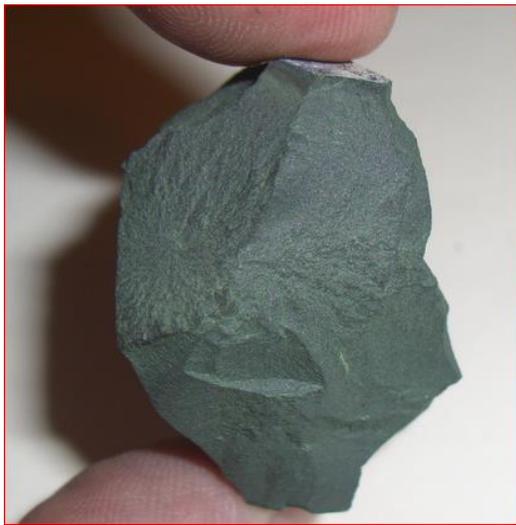
Trick of the Trade: Removal of the faulted section of the disk and AC testing of the chipped parts can reveal TOV overload.

Figure 15 Section of disk chipped out for testing without influence of faulted section

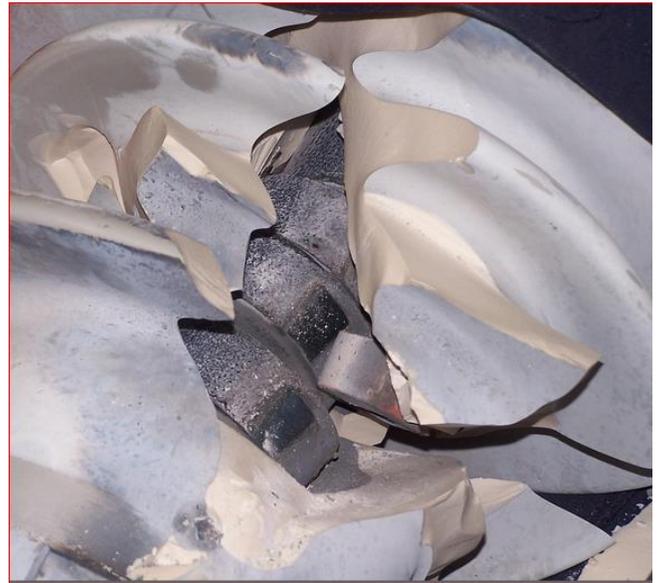
Figure 16 Always take great caution when handling fractured porcelain, the edges are razor sharp
