Small Power Station Surge Protection Analysis and Plan

Jonathan Woodworth ArresterWorks

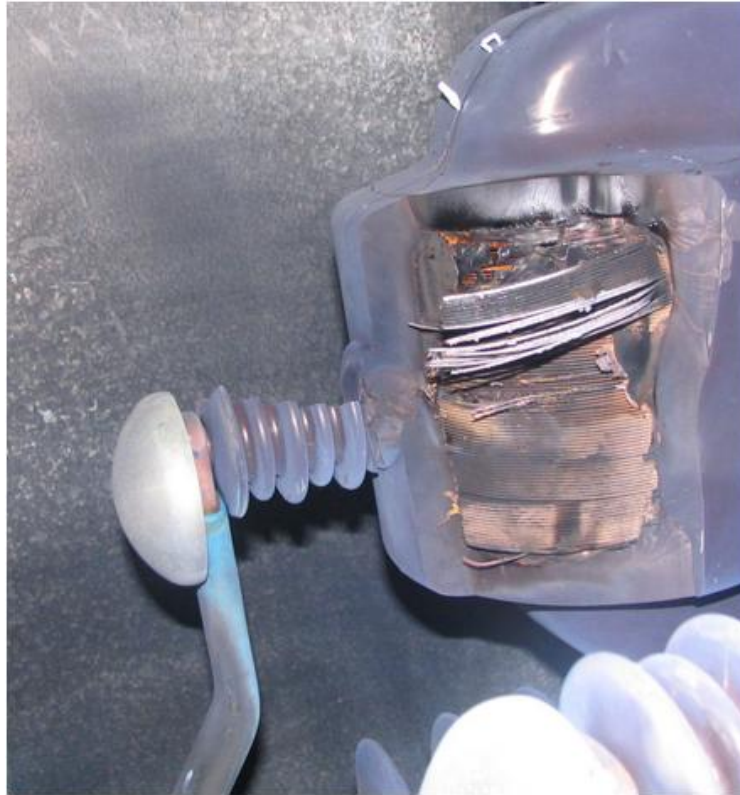
The County landfill gas generating station is an 11 year old 3 MW, three unit generator feeding a 34.5kV distribution system. The station has experienced lightning related outages several times with a significant event in 2011 that caused a disconnect switch to fail. The plant grounds were checked and improved after the 2011 event. Three 36.5kV arresters were installed in the utility side of the main breaker. The station was put back on line and in late May of 2012, it experienced another lightning related outage. This time a PT failed and caused a phase to ground fault as well as a phase to phase fault in the main switchgear.

Figure 1: Failed PT in Switchgear cabinet

- i. Either the PT failure was due to previously weakened insulation or the rate of rise of the surge in the last event exceeded the insulation withstand.

3. The last failure event appears to be a surge that entered the switchgear module from the incoming 34.5kV line.
4. Pre 2011 failures of the elbows were likely caused by a voltage doubling of an incoming surge that traveled past the 27kV arresters on the metering pole and doubled at the end point of the circuit.

- 6.1 Insure that when the new breaker module arrives, it has 36kV arresters pre-installed. (referred to as A2 in this report)
- 6.2 Add 35kV, .13uF surge capacitors as specified in Annex A in parallel with Arresters A1.
- 6.3 Add 35kV elbow arresters at the end of the circuit in GM3 as specified in Annex A.
- 6.4 Consider having an overhead shield wire and line arresters added to 10 spans out from the station.
- 6.5 Consider working with First Energy to improve the protection of the revenue meter with surge arresters.

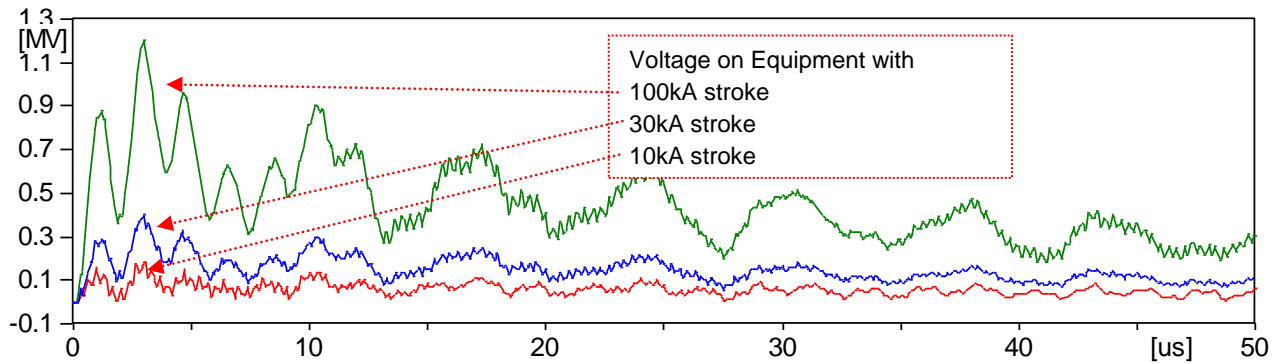
To demonstrate the effect of a direct strike on the system several different current levels were modeled with no protection in the generator or EEM. A worst case scenario was used with a strike to the line at the riser pole. Figure 3 shows these results. It can be seen that at the 10kA stroke level the voltages on the equipment would be 100-150kV. With a 30kA stroke, the voltages reach the 300kV range, but of course something would have flashed over

and reduced this level significantly. With a 100kA stroke to the riser pole, the unmitigated voltage levels in the plant would be over 1megavolt.

Figure 3: Voltage on the equipment in the EEM with no arrester protection (Scenario 1, 2, 3)

It can be seen in figure 3 that even with a riser pole arrester mounted on the Utility Pole, the voltage in the EEM exceed 300kV even with stroke currents as low as 30kA. This lack of protection of the EEM is due to the separation distance between the riser pole arresters and the EEM. In effect there is 40-50 feet of down ground to the bottom of the riser pole and another 40-50 feet to the tie in of the ground grid. These two lengths represent significant inductance which is the most important characteristic of ground cable with respect to lightning. The long leads result in no protection for the EEM from the riser pole arresters.

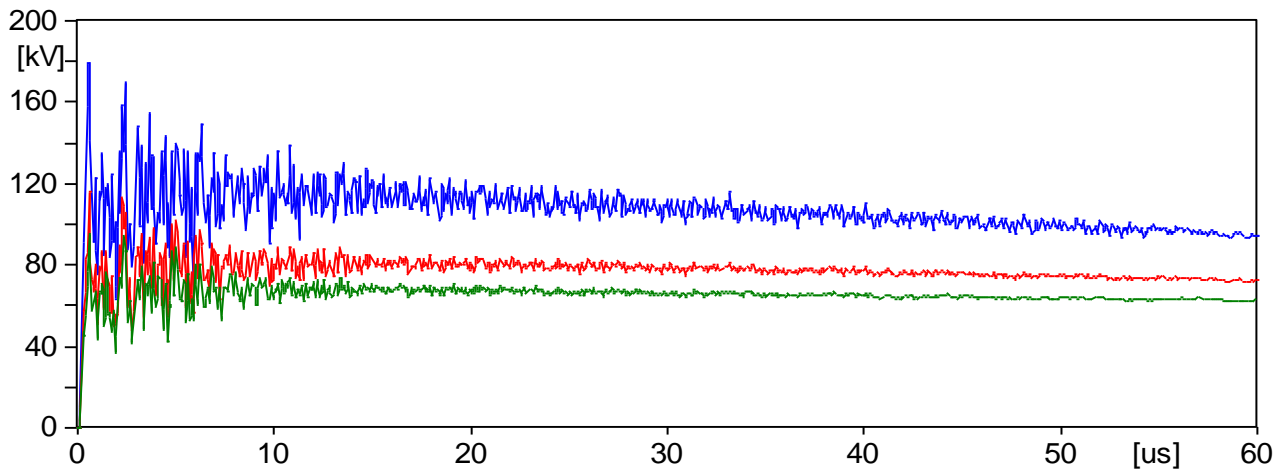
Figure 4 Strike to Riser Pole configured as it was on May 29, 2012 (Scenario 4,5,6)

Figure 4 shows that with a strike of 100kA magnitude to the span next to the riser pole, that the voltage level on the equipment in the EEM could see levels above the 170kV BIL rating. On the May 29th strike, there was no report of a strike that close, but this graph shows that excessive level was possible even with the 36kV arrester (A1) installed in the cabinet. It is possible that PT2 was pre damaged from the August 2011 event and that it did not take a full 170kV to cause it to fail this time. It could also be that the rapid rate of rise of the final surge (whatever level it was) could have done the damage.

- 5.2 The addition of a 36kV arrester (A1) at the utility side of breaker 52 was a positive move, but from Scenario 4 it appears possible that the system BIL could still be compromised if a high current stroke hit near the riser pole. (It is understood that this was not the case on May 29th, but perhaps it happened earlier when no operator was in house)

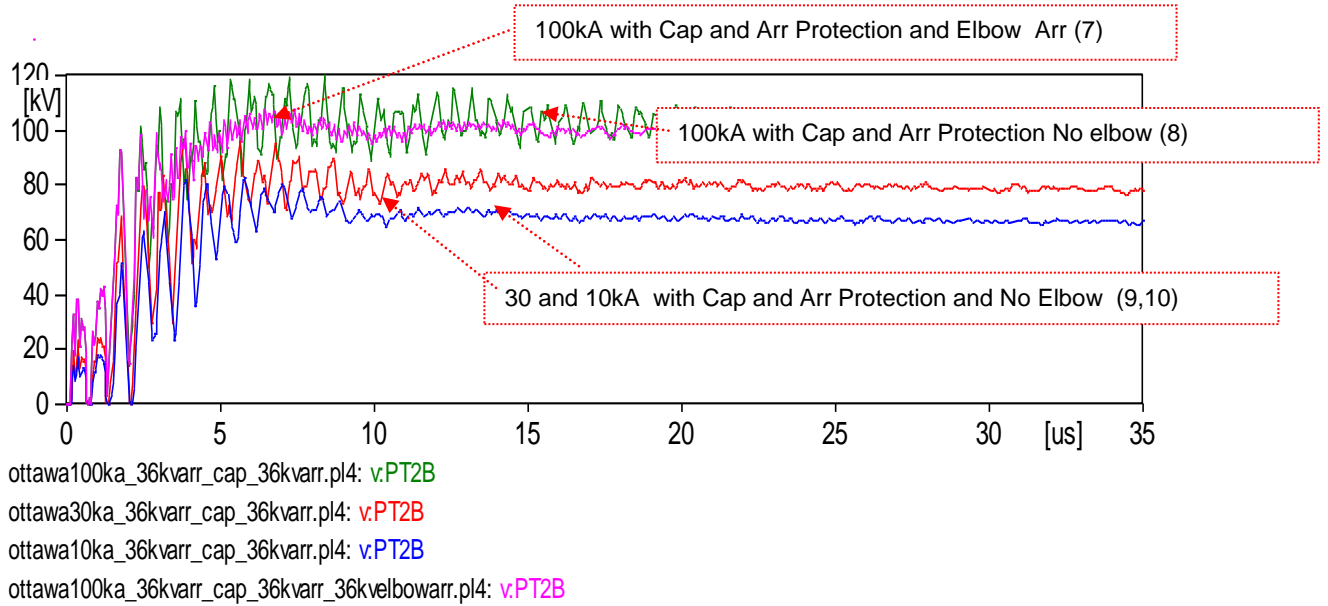
Figure 5 EEM Equipment voltage with Various Protection Schemes and Current Levels with strokes to line at riser pole (Scenario 7,8,9,10)

1. Elbow arresters at generator 3
2. 36kV arrester on generator side of breaker 52 (as proposed by Schneider)
3. Surge capacitor in parallel with present 36.5kV arrester.

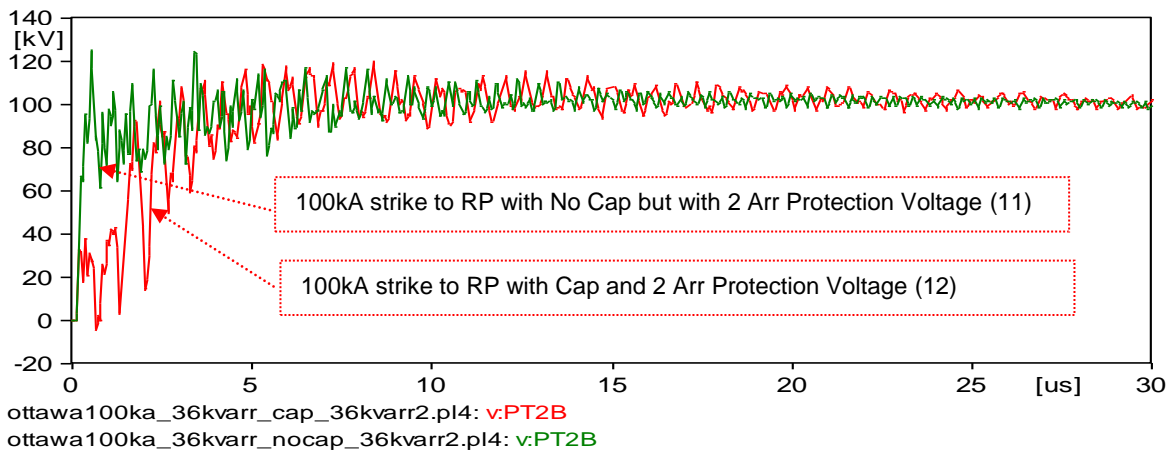
Figure 6 Simulation with and without Surge Capacitor in the circuit with 100kA stroke to Riser Pole (Scenario 11,12)

To better demonstrate the effect of the surge capacitor, a worst case scenario was executed with and without the surge capacitor in the circuit. It can be seen in Figure 6 that for 100kA stroke to the span in front of the riser pole, the maximum rate of rise is decreased and the maximum amplitude of the surge at the EEM is reduced.

- 5.4 For one level better protection, the inclusion of a surge capacitor in parallel with Arresters A1 is positive. Scenarios 11 and 12 show the improvement.

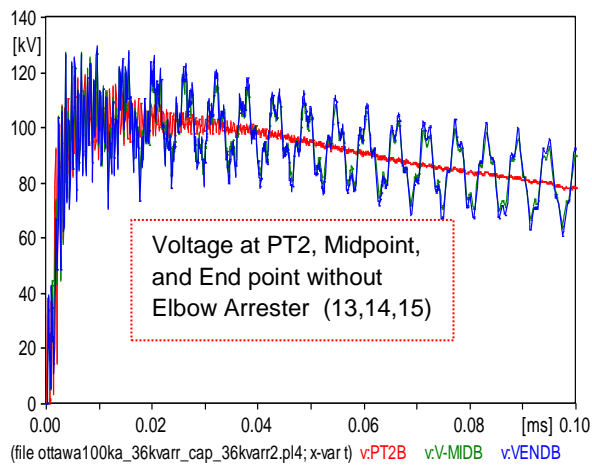
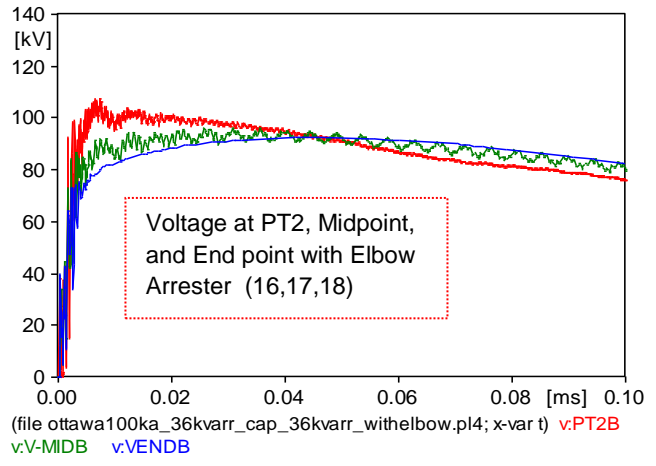
Figure 7a and b: Voltage at PT2, Mid point and end Point. 7a is without Elbow Arrester, and 7b is with elbow arrester. (Scenario 13,14, 15,16,17,18)

A check of the voltage at other points in the circuit, with the optimum configuration of Cap, 36kV arr, 36kV arr, show that the voltage at the midpoint in the circuit is higher than at PT2. With an elbow arrester installed at the end point these elevated voltages are removed. See Figures 7a and 7b.

- 5.5 To reduce voltage stresses at the midpoint and endpoint of the circuit, the addition of an elbow arrester at generator 3 is positive. Scenarios 13-18 show the improvement.
